# Impact Damage Mechanisms of 3-D Carbon-Carbon Materials

Materials Sciences Laboratory ✓  
Laboratory Operations  
The Aerospace Corporation  
El Segundo, California, 90245

23 July 1976

Final Report  
(1 July - 31 August 1975)

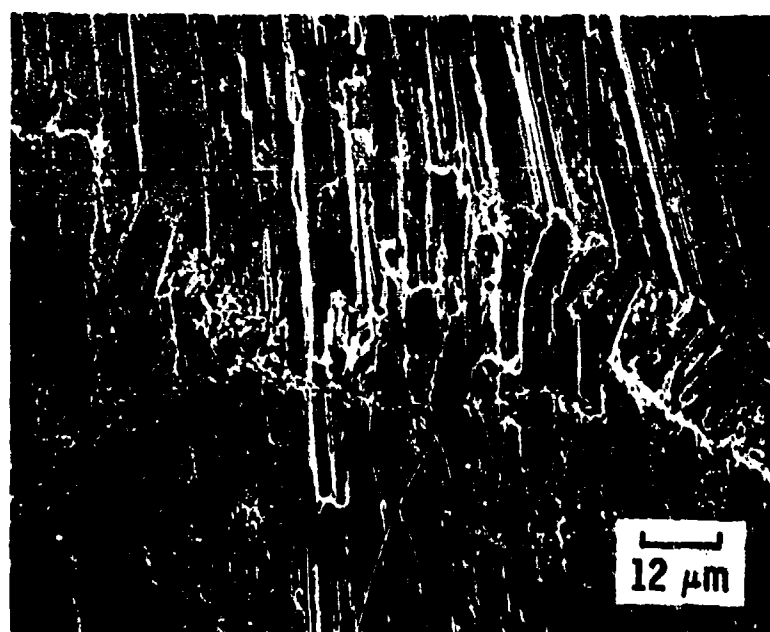
Figure 6. Z Fiber Bundle Column Buckling Failure

Additional examples of Z fiber fracture and displacement to yield column buckling can be seen in Figure 6. This fiber bundle (Grid J-L/19) is also at the base of the impact crater and has been subjected to high compressive loads. An enlargement of this area, Figure 7 (Grid F-L/19-21), shows that the adjacent Z fiber bundle has no apparent in-depth damage, and where it extends into the crater region, the fibers have been cleanly fractured in a mode other than compression since no fiber displacement is evident. It may be observed, however, that this entire Z fiber bundle has been bent away from the crater centerline. The relative direction of the impact forces during crater formation can thus be deduced. The fiber bundle subject to axial loading responded by a buckling failure while the adjacent fiber bundle, intersecting the crater in a side wall area, has had insufficient axial loading for buckling to occur as well as sufficient side loading to produce bending of the entire bundle.
